# 155-mm Howitzer Malfunction Investigation: A Laboratory Study of the Igniter Train Operation

ARL-TR-2106

November 1999

# **Army Research Laboratory**

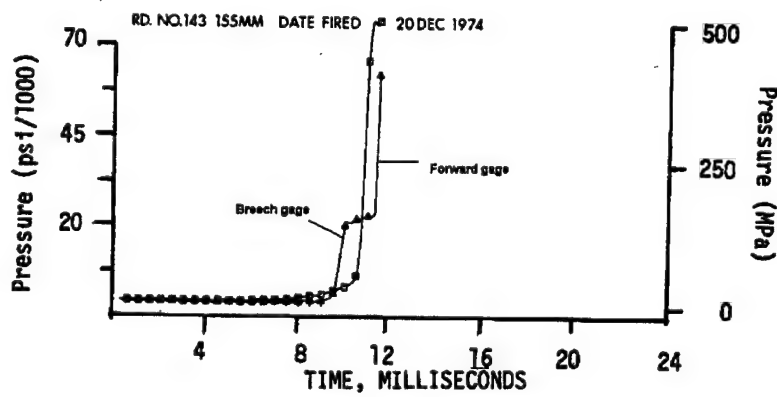
- Round 142: Hangfire, 10 s (minimum, not measured); muzzle velocity, 857 m/s (2,812 ft/s) and 61 m/s (200 ft/s) higher than a normal cold round; mean chamber pressure, 379 MPa (55,000 psi) and  $\sim 110$  MPa (16,000 psi) higher than a normal cold round.
- Round 143: Hangfire, 5.8 s (measured); erratic pressure vs. time trace with a chamber pressure in excess of 793 MPa (115,000 psi) causing a breechblow and extensive damage to the XM199E5 cannon tube. The pressure vs. time history for this round is shown in Figure 2.

Figure 2. Pressure-Time Trace of Breechblow Round Fired at APG With XM203E1 Charge Conditioned to -54° C in XM198 Howitzer.

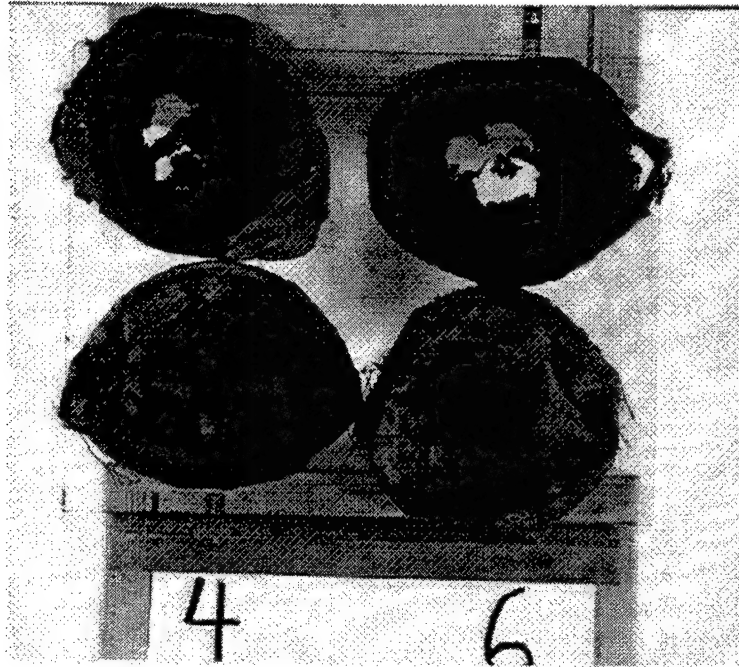
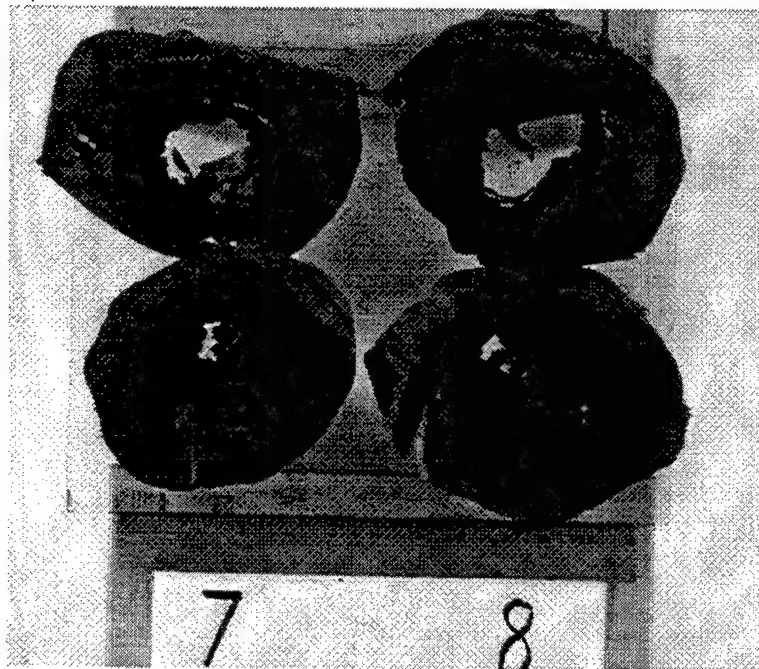
**3.1.4 Run 6.** Runs 4 ( $-54^{\circ}\text{C}$ ) and 6 ( $+12^{\circ}\text{C}$ ) post-firing photos are shown in Figure 7(a). It is seen that there are no significant differences between the low-temperature and ambient firings. Results in Table 1 indicate that the time to peak pressure is slightly longer for the cold runs (54 ms) than for the ambient runs (35 ms). However, no events with delays in the range of seconds were observed. Pressure-time traces are shown in Figures 8 (Gauge 1) and 9 (Gauge 3).

**3.1.6 Run 8.** Results were very similar to that of Run 5, which used the 203 material at  $-54^{\circ}\text{C}$ . The post-firing photo of base pad and propellant bag of Runs 7 and 8 are shown in Figure 7(b).

**Figure 7. Post-Firing Photographs of Bass Pad (Top) and Propellant Bag (Bottom). 28 g (1 oz) of Black Powder Used in Base Pad; (a) 203, (b) 123.**

Again, no significant difference is seen due to the conditioning temperature. Close observation of Figure 7 shows, however, that there are some differences in cloth penetration between the 123 (viscose-rayon impregnated resin) and the 203 (polyester-viscose rayon). The 123 cloth (Figure 7[b]) is more subject to ignition damage than the 203 cloth. In fact, no penetration of the propellant bag is observed in Figure 7(a), whereas there are several holes in the propellant bag in Figure 7(b). Apparently, this difference in cloth had no substantial effect on the operation of the black powder, but it did inhibit the damaging effect of primer black powder output on the propellant bag. Pressure-time traces are shown in Figures 13 (Gauge 1) and 14 (Gauge 3).

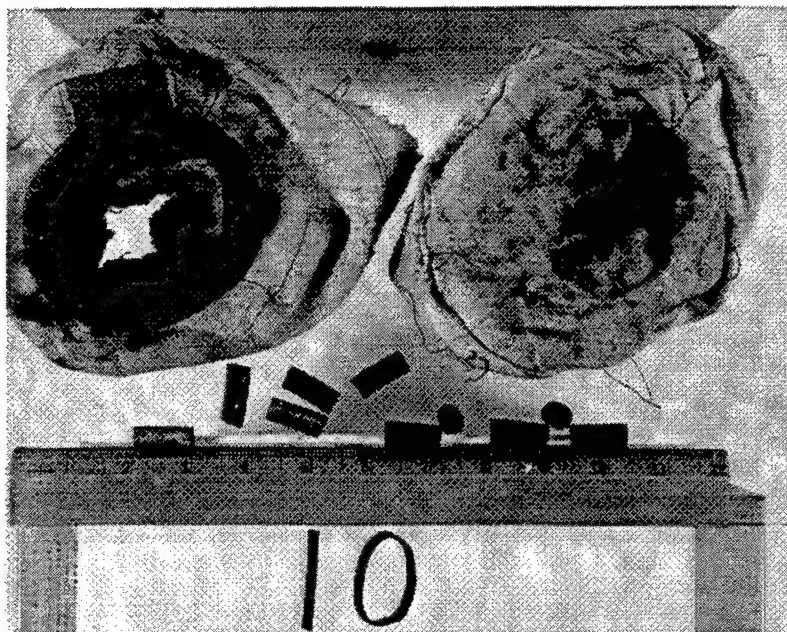
**3.2.2 Run 10.** In this case, the propellant was placed in the base pad in direct alignment with the M82 primer output. A photograph of the base pad, propellant bag, and propellant is given in Figure 15. It can be seen that some of the graphite coating has been removed from the propellant

**Figure 15. The 203 Base Pad (Left) and Propellant Bag (Right) for Run 10. Propellant Grains Placed in Base Pad. Some Graphite Coating Removed From the Grains by the M82 Output. No Evidence of Reaction.**

grains, but there is no evidence of propellant reaction. It may also be noted that there was no penetration of the propellant bag.

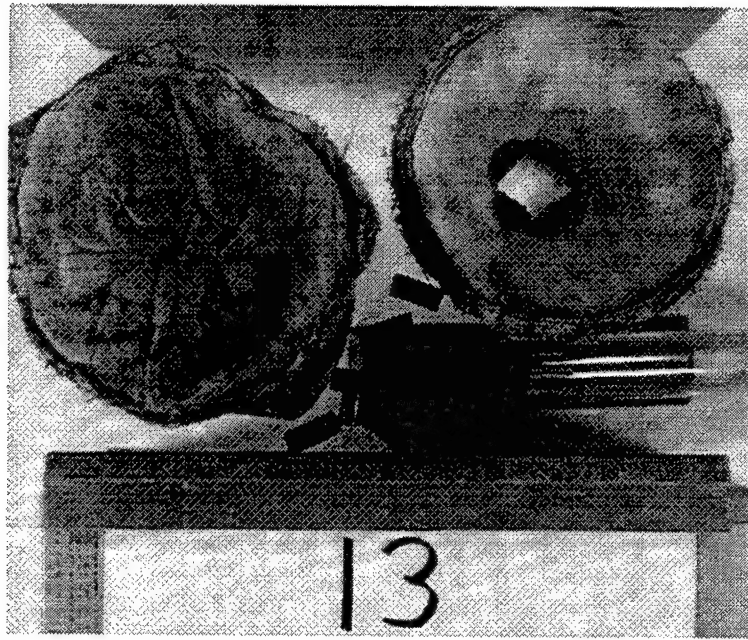
**Figure 16. Post-Firing Photograph of Run 13: Propellant Bag (Left) and Flash Reducer (Right).**

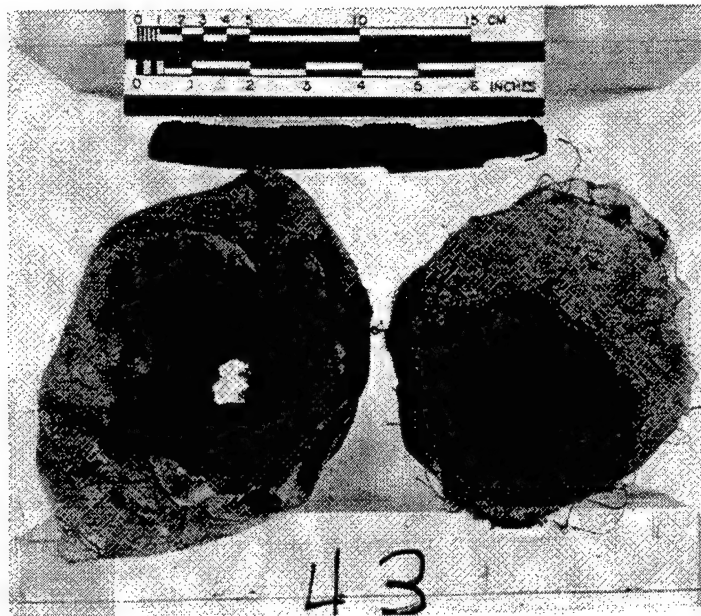
**3.7.5 Run 43.** For this run and Run 44, a flash reducer was put on the far end of the charge (in front of Gauge 3, Figure 3[a]). The reason for this was because the pressure pulse from the M82 was reflected at the far end of the charge against the Gauge 3 wall. This could raise the gas temperature considerably and enhance the possibilities of ignition of the snake. (Runs 15 and 26–29 were carried out in this manner). The flash reducer would deflect the pressure pulse and inhibit this mechanism. For this run only, the NC tube ignited. The snake cloth was charred, but the black powder did not ignite (Figure 27). This test also demonstrated that the NC tube could itself ignite but that it would not necessarily ignite the black powder. Thus, it is conceivable that the M82 would ignite the end of the NC tube and this, in turn, could ignite the propellant without igniting the black powder snake.

**Figure 27. Post-Firing Photograph, Run 43. Base Pad (Left Empty), Snake (Top 0.05 kg [1.75 oz]). NC Tube Completely Burned Up. Snake Cloth Was Charred, but Black Powder Did Not Ignite.**

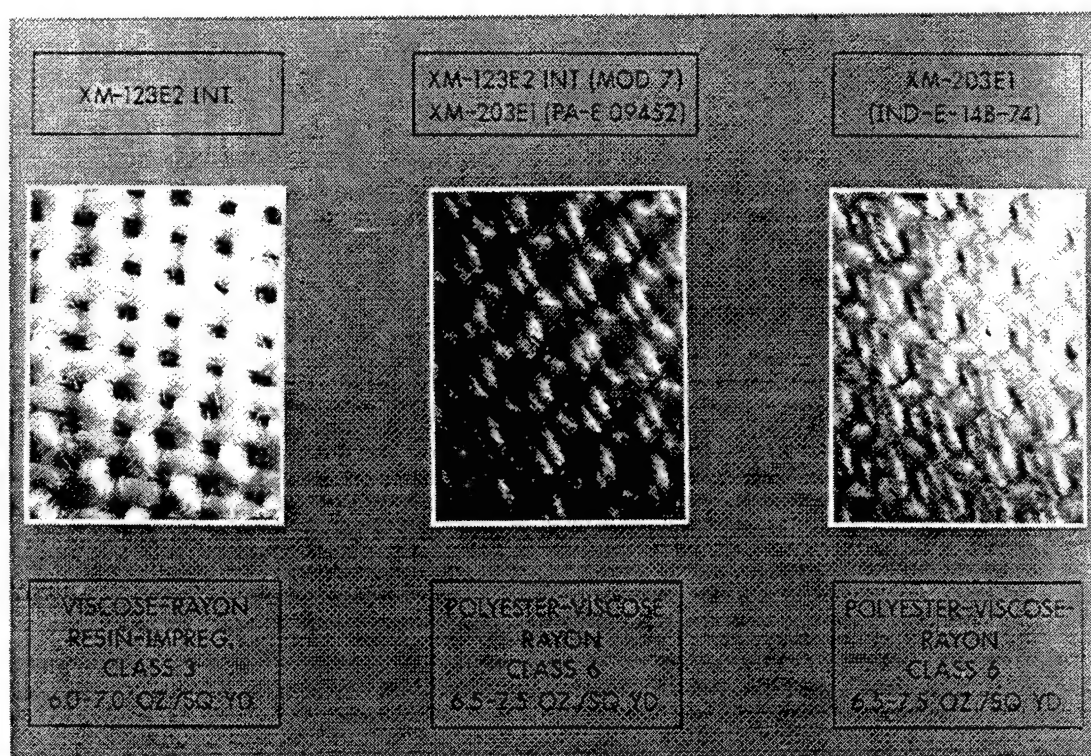
In referring to Figure 43, it can be seen that there is a substantial difference in cloth porosity between the cloth used in the 123 charge and the cloth used in the 203 charge. Only the inner base pad cloth is shown. Figure 7 shows the residue of the base pad (top) and propellant bag (bottom) after firing of an abbreviated charge, as in Figure 4. The base pad contained 28 g (1 oz) of black powder, there was no snake, and an inert central core tube was used.

**Figure 43. Inner Lining of Base Pad Cloths Used in 123 Interim (Left) and 203 (Right). The XM123E2 Interim (Mod 7) Cloth Is Not Discussed in This Report.**

It is seen that the penetration of and damage to the propellant bag is substantially greater for the 123 system than the 203 system. Apparently, the heavier cloth with a finer weave inhibits the transfer of energy into the propellant bed. The pressure-time curves of two different base pads (Figures 5 and 13) do not show any substantial difference, which indicates that the overall energy output is not altered and only the transfer of energy to the propellant is affected by the cloth.
